Military Wall Art

Military Wall Art: Guidelines on its significance, conservation and management

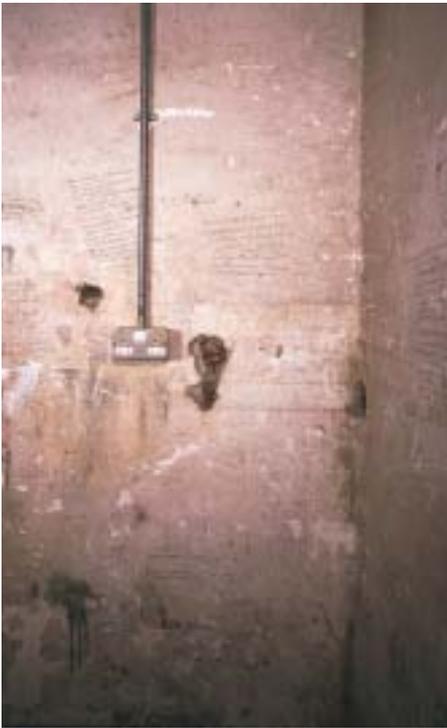
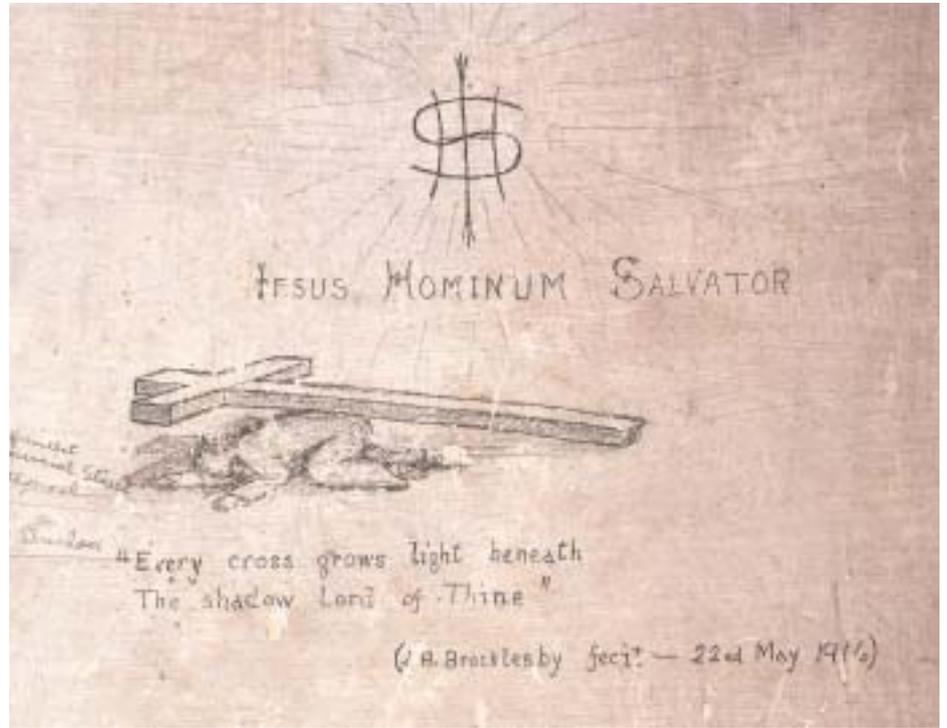
Details of graffiti drawn by conscientious objectors on cell walls at Richmond Castle, Yorkshire, in 1916. Decisions were made to restrict physical access to the small detention cells due to the significance and extreme fragility of the graffiti.

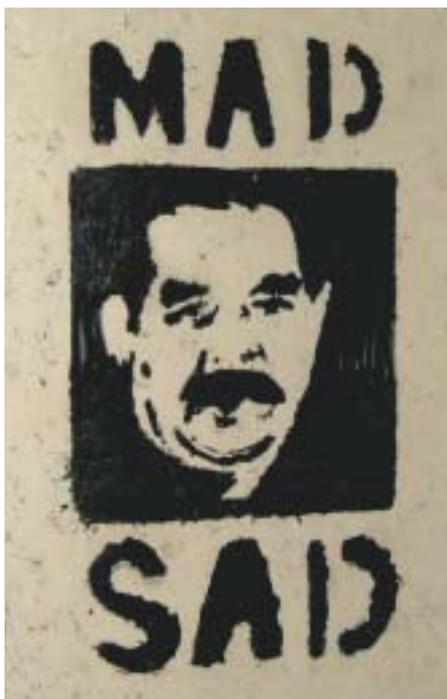
During both the First and Second World Wars, and subsequently, stencils and spray paint were used to produce repeatable images. A range of designs have been found including this one in a Royal Navy isolation magazine. (© Roger J C Thomas)

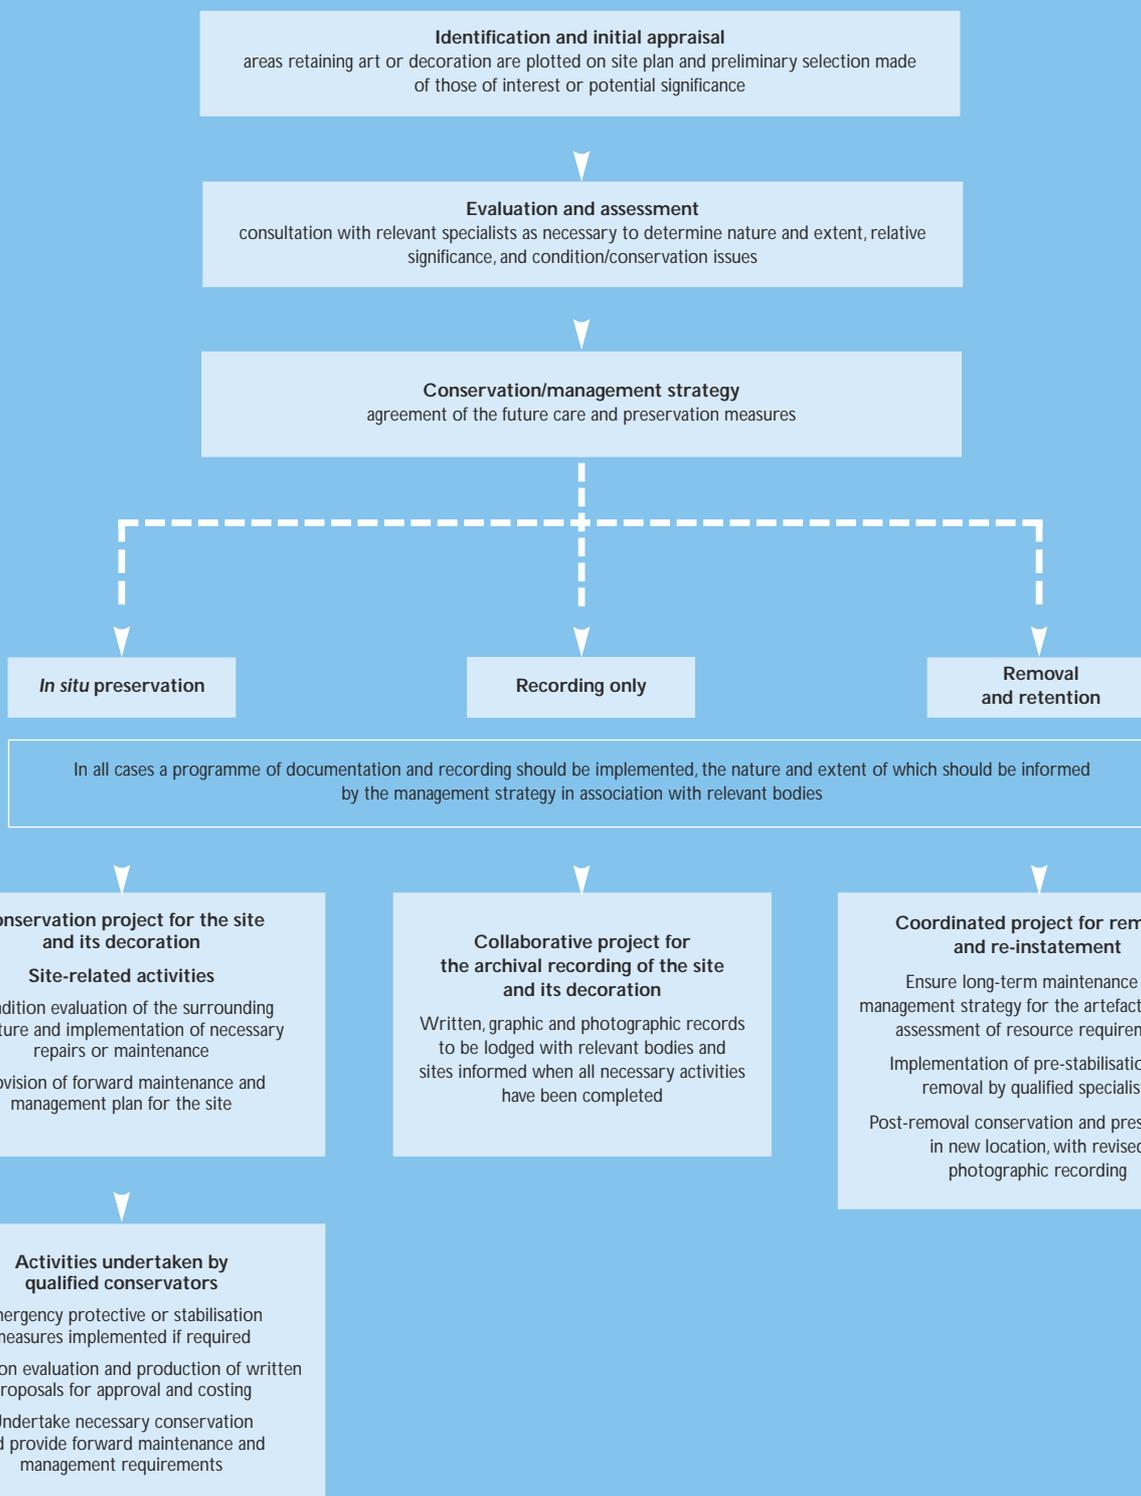
KEY STAGES FOR DEALING WITH MILITARY WALL ART

The following summary table provides a schematic sequence of the stages needed in developing an appropriate conservation and management strategy for military wall art.

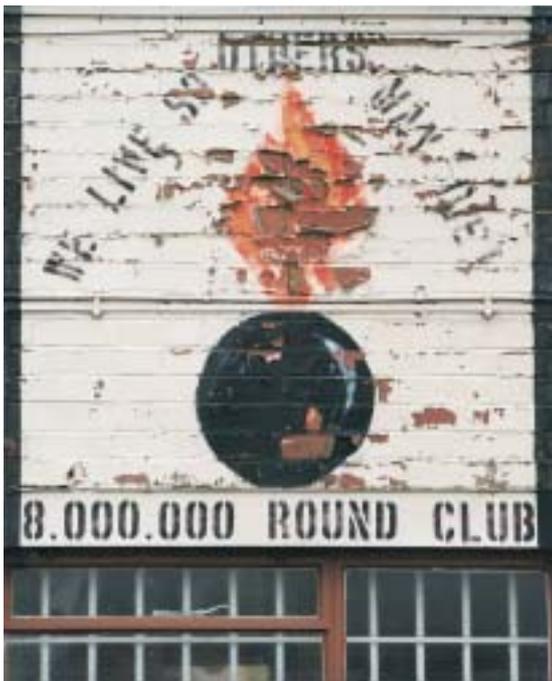
RAF Bentwaters, Suffolk: 'We live so others may die! 8,000,000 Round Club'. Images painted on external walls are very vulnerable to weathering, in particular when modern impermeable paints are used. (AA021677)

Paintings on building exteriors are particularly vulnerable to weathering and remedial conservation may not be feasible over the long term. The resulting dilemmas are well illustrated by the conservation problems faced by the Berlin conservation authorities, obliged to deal with the decay of the 'East Side Gallery', a 1.3km-stretch of the Berlin Wall decorated by many international artists in 1990. Rather than attempt to conserve the Gallery itself, the original artists were invited to make copies of their work, which have been termed 'second originals'.

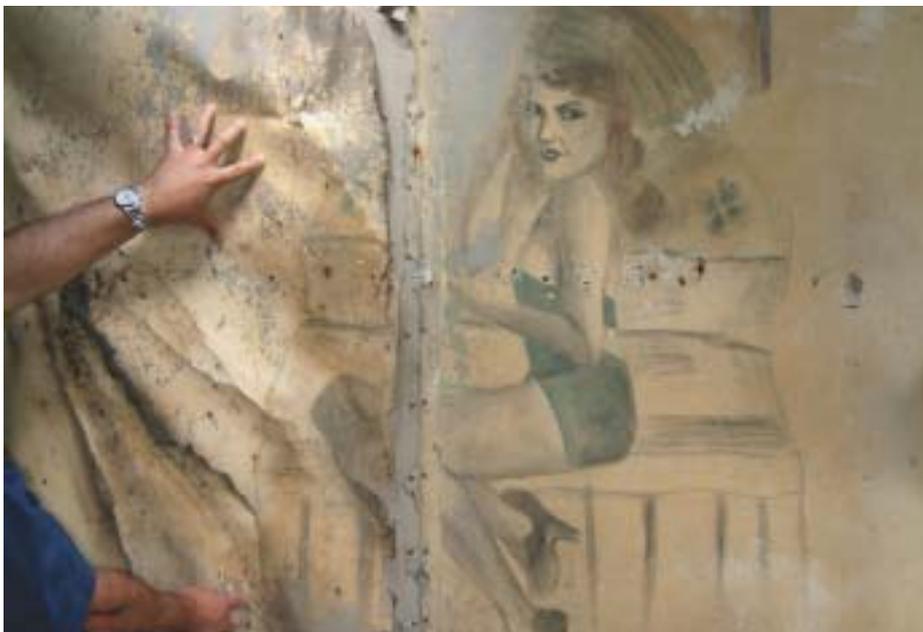
The deterioration of this image, in the prisoner-of-war camp at Pingley Farm, Lincolnshire, is directly related to the ongoing dilapidation of the building, which has caused direct water ingress. (© Roger J C Thomas)

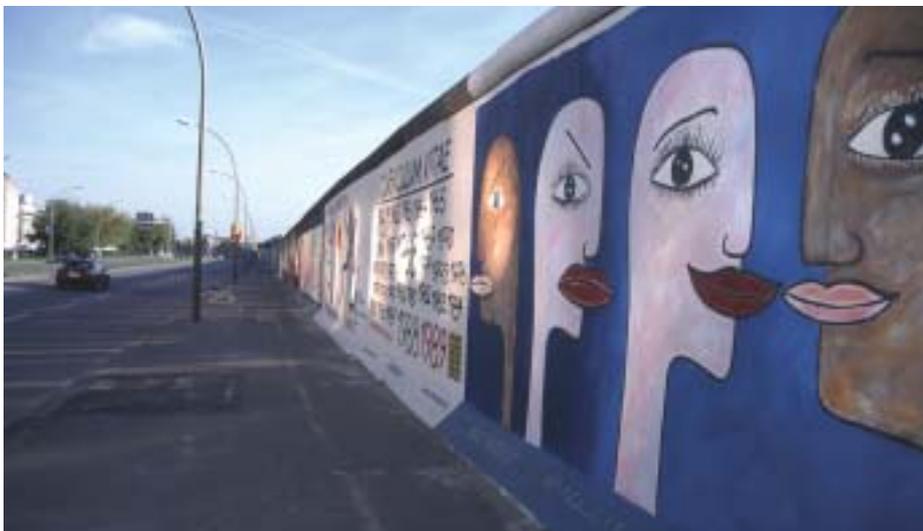
East Side Gallery, Mühlenstrasse, Berlin. Tolerance by Mary Mackey of Denver, Colorado, photographed in September 2000 shortly after the image was repainted by the artist. (© Wayne Cocroft)
